# **Environmental impacts of the oil spill at Ikot Ada Udo in Akwa Ibom State, Nigeria**

**Submitted by Prof. E. J. Udo,  
PAM Scientific Laboratories,  
Uyo, Nigeria,  
for Environmental Rights Action/  
Friends of the Earth.**

**May, 2008.**

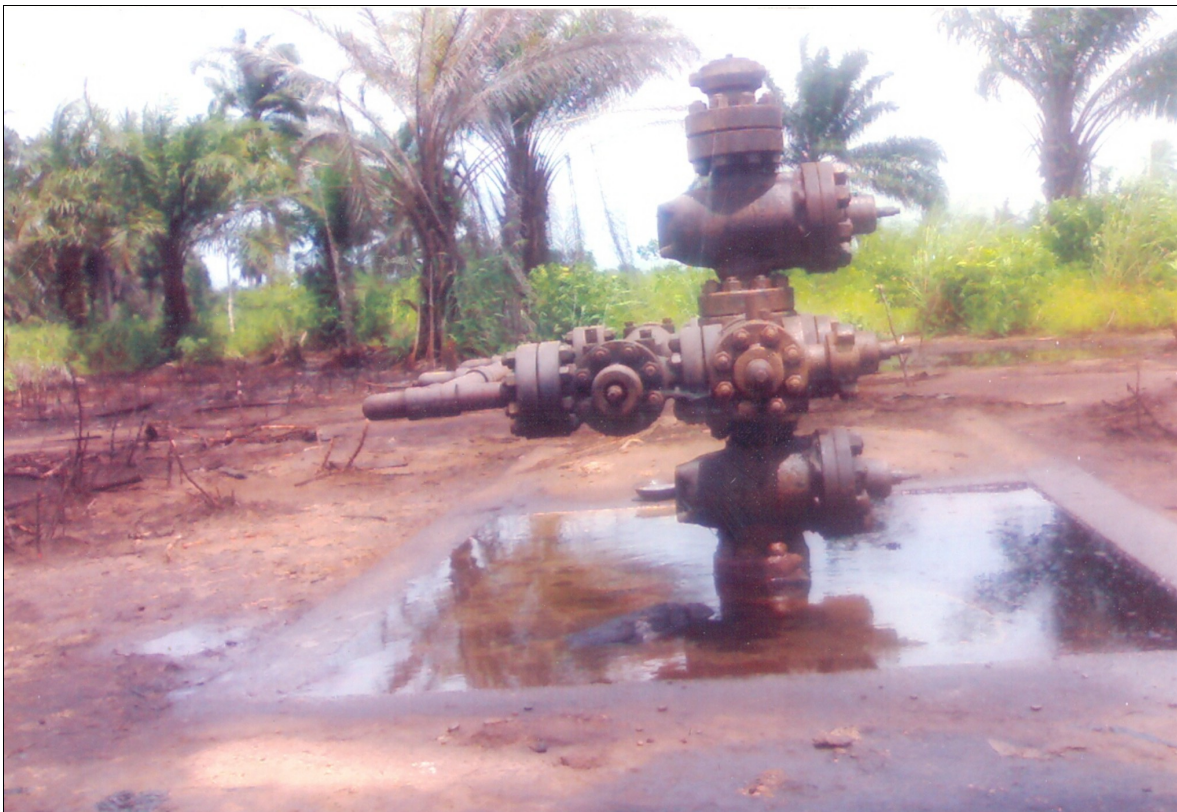
**Plate 1: Ibibio 1 corked well at Ikot Ada Udo.**

The corked oil well is located on a farmland. At the time of the study, oil had leaked from the corked well and spread to a large area of the farmland destroying all the crops, weeds and other plants on the land. It is only the oil palm trees that are left in the area (Plates 1, 2 and 3)

It is strongly recommended that the Well Head will be adequately monitored to ensure that no further spillage occurs in future.
